INDOOR AIR QUALITY ASSESSMENT

**Watertown Fire Department, Station 3
270 Orchard Street
Watertown, MA 02472**

Prepared by:
Massachusetts Department of Public Health
Center for Environmental Health
Bureau of Environmental Health Assessment
Emergency Response/Indoor Air Quality Program
April 2005

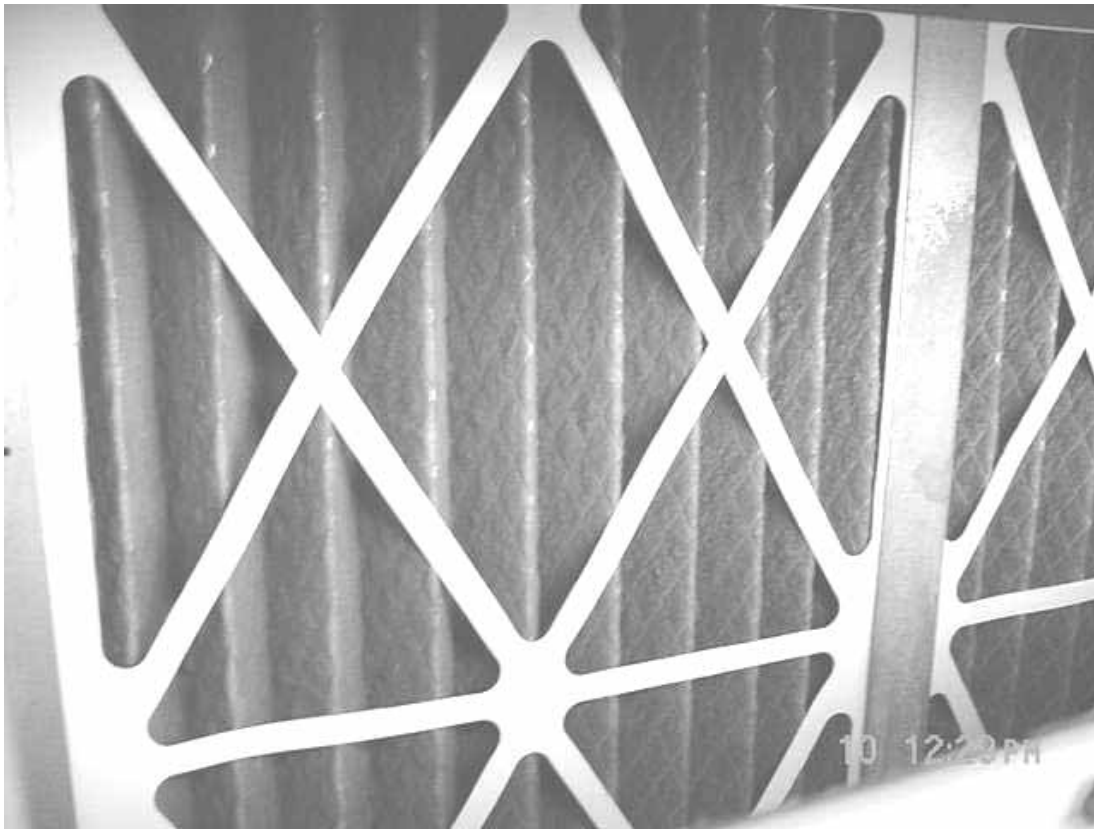
Picture 1

It can be seen from Table 1 that carbon dioxide levels were below 800 parts per million (ppm) in all occupied areas surveyed, indicating adequate air exchange. Mechanical ventilation is provided by a rooftop air-handling unit (AHU) equipped with high efficiency pleated air filters (Picture 1). However, WFD staff could not identify the date of the last filter change for the AHU. CEH staff examined the AHU and found the filter occluded with dirt and dust (Picture 1). The AHUs provide conditioned outside air through ducted ceiling vents (Picture 2), and air is returned to the AHUs via ducted wall or ceiling-mounted vents (Picture 3). Thermostats that control the HVAC system have fan settings of “on” and “automatic”. Thermostats set to the “automatic” setting were

High-Efficiency Pleated Air Filter in Rooftop AHU

8. Change filters for HVAC equipment as per the manufacturer’s instructions or more frequently if needed.
9. Balance mechanical ventilation systems every five years, as recommended by ventilation industrial standards (SMACNA, 1994). Consult a ventilation engineer concerning re-balancing of the ventilation systems.

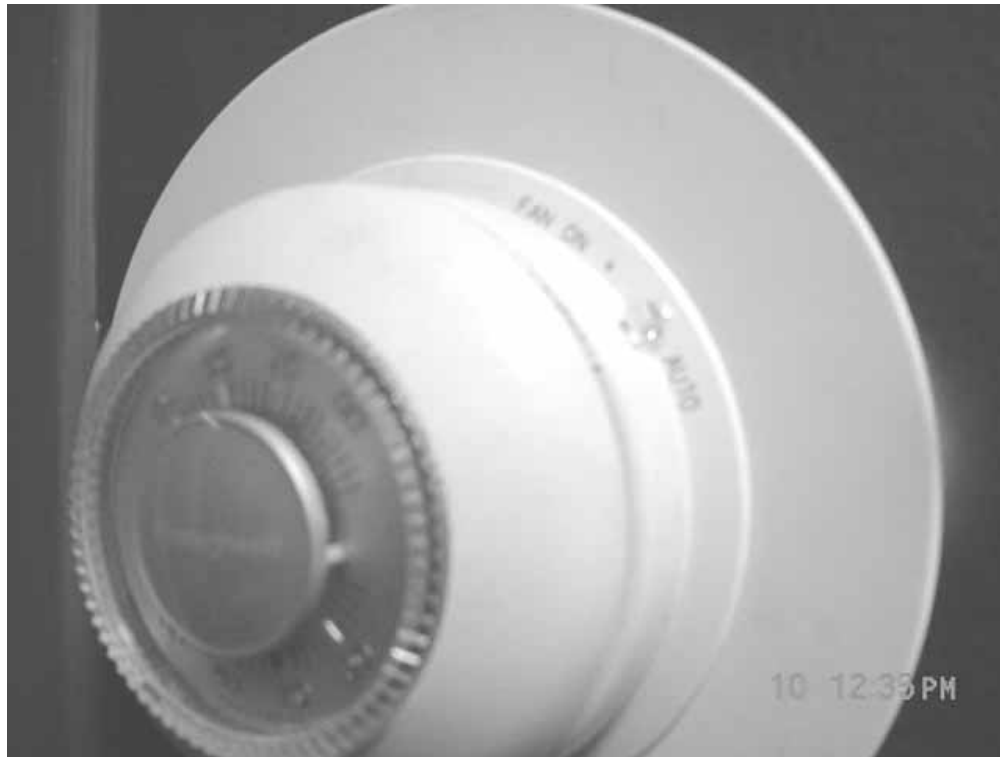
Picture 4

observed during the assessment (Picture 4). The automatic setting of the thermostat activates the HVAC system at a preset temperature. Once the preset temperature is reached, the HVAC system is deactivated. Therefore, no mechanical ventilation is provided until the thermostat re-activates the system.

HVAC Thermostat Fan Set to “Auto” Setting

6. Work with town officials to develop a preventative maintenance program for all HVAC equipment department wide.
7. Operate thermostats in the fan “on” setting during occupancy to provide continuous air circulation.

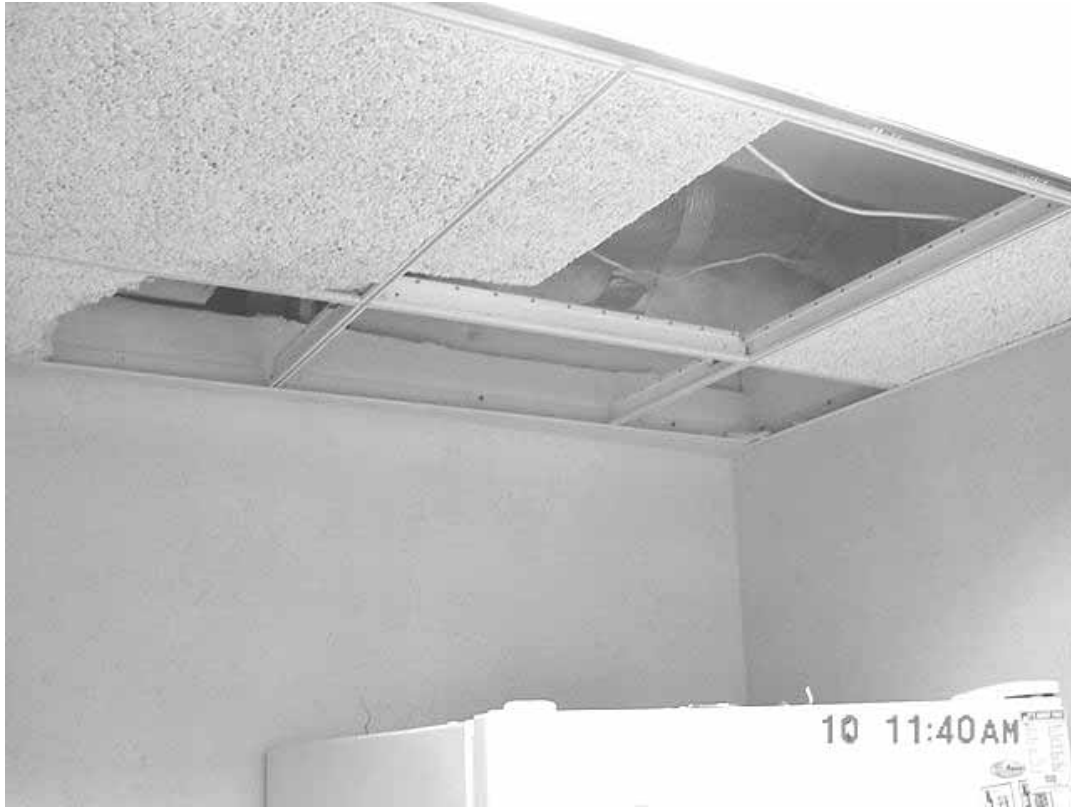
Picture 5

A number of areas had water-damaged ceiling tiles (Picture 5). Occupants reported that ceiling tiles became damaged as a result of roof leaks that had since been repaired. Water-damaged ceiling tiles can provide a source of mold and should be replaced after a moisture source or leak is discovered and repaired.

Missing/Water Damaged Ceiling Tiles

11. Ensure roof leaks are repaired. Replace water-damaged ceiling tiles. Examine the area above and behind these areas for microbial growth. Disinfect areas of water leaks with an appropriate antimicrobial.

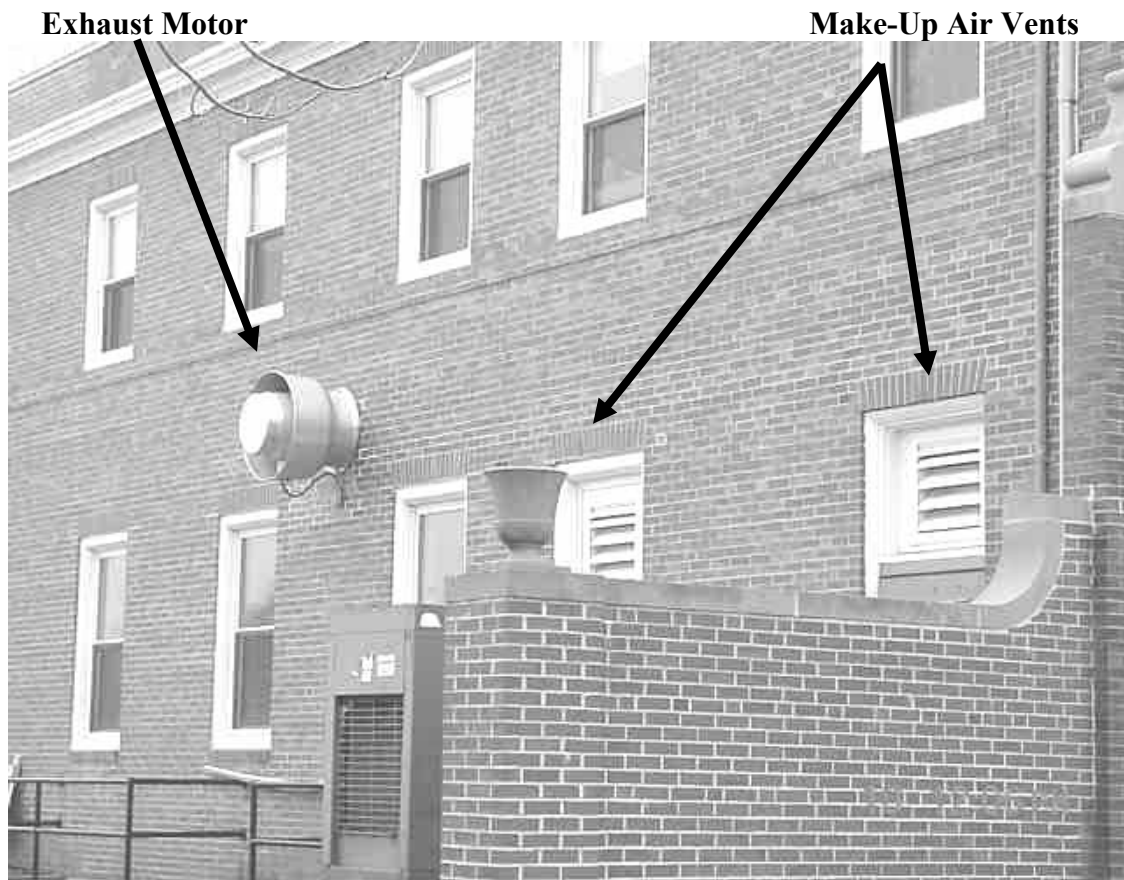
Picture 7

As mentioned previously, the station is equipped with a mechanical exhaust system to remove exhaust from the engine bay during vehicle idling. The local exhaust system consists of a series of exhaust vents that feed into a main duct connected to a large exhaust motor located in the exterior wall of engine bay (Pictures 6 and 7). Make up air is provided through louvered vents on exterior walls of the engine bay (Pictures 7 and 8). The activation of the system appears to be dependent on the detection of carbon monoxide and nitrogen dioxide levels measured by sensors (Pictures 9 and 10). Once a pre-set reading is exceeded, the local exhaust system is activated to introduce fresh air and remove exhaust emissions. Therefore, no mechanical exhaust ventilation is provided until the set-point is exceeded to activate the system.

Exterior Wall of Engine Bay Showing Exhaust Motor and Supply Vents for Local Exhaust System

1. Manually activate local exhaust system upon exiting *and* returning to engine bays.
2. Contact the manufacture and/or installer regarding the operation and calibration of the chemical sensor/local exhaust ventilation system. Maintain and calibrate it in accordance with the manufacturer's instructions.

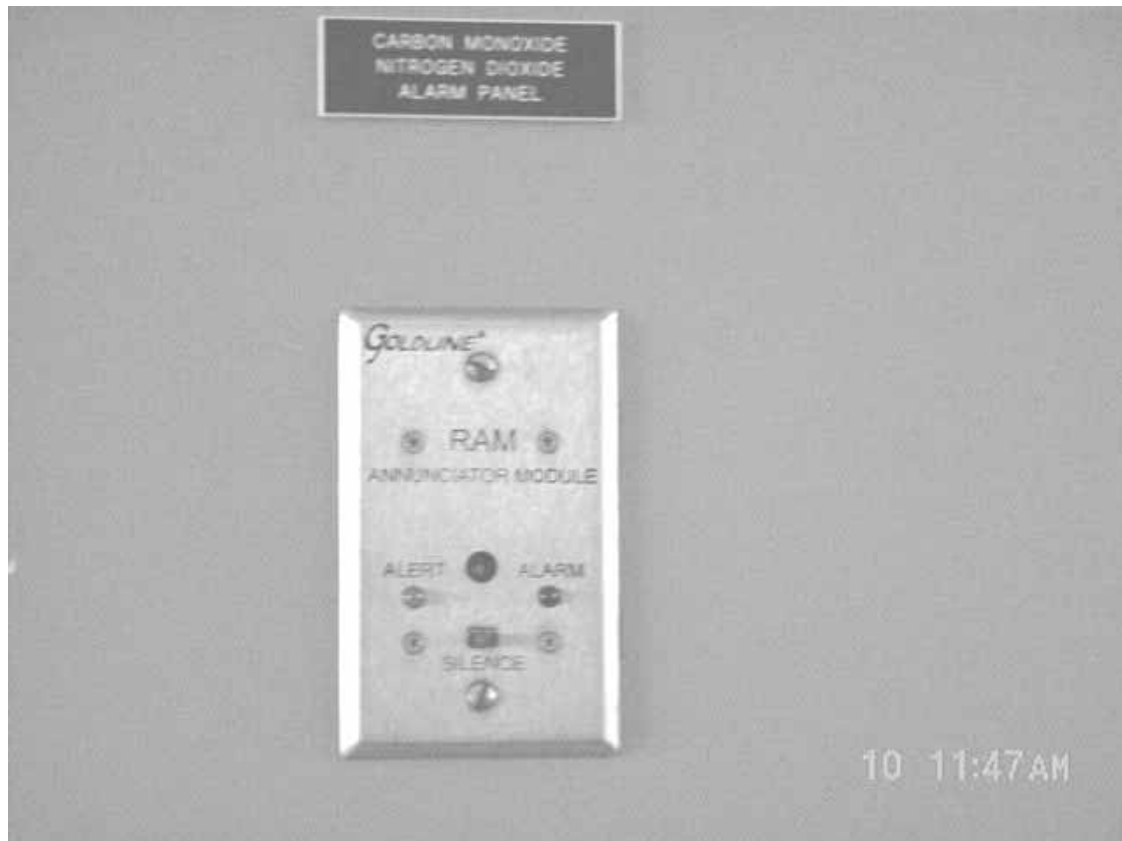
Picture 9

As discussed, BEHA staff had the WFD personnel simulate a call, in which all fire-fighting and emergency support vehicles were started, removed from and returned to the engine bay. Neither during this activity nor after did the local exhaust system activate to remove vehicle emissions. In addition, WFD personnel could not identify what the set-points for the chemical sensors were or the last time they were serviced and/or calibrated. However, approximately 5-10 minutes after the simulated call, CEH staff observed a member of the WFD activate the system via a manual override switch.

Chemical Sensor Alarm Panel for Local Exhaust System in Engine Bay

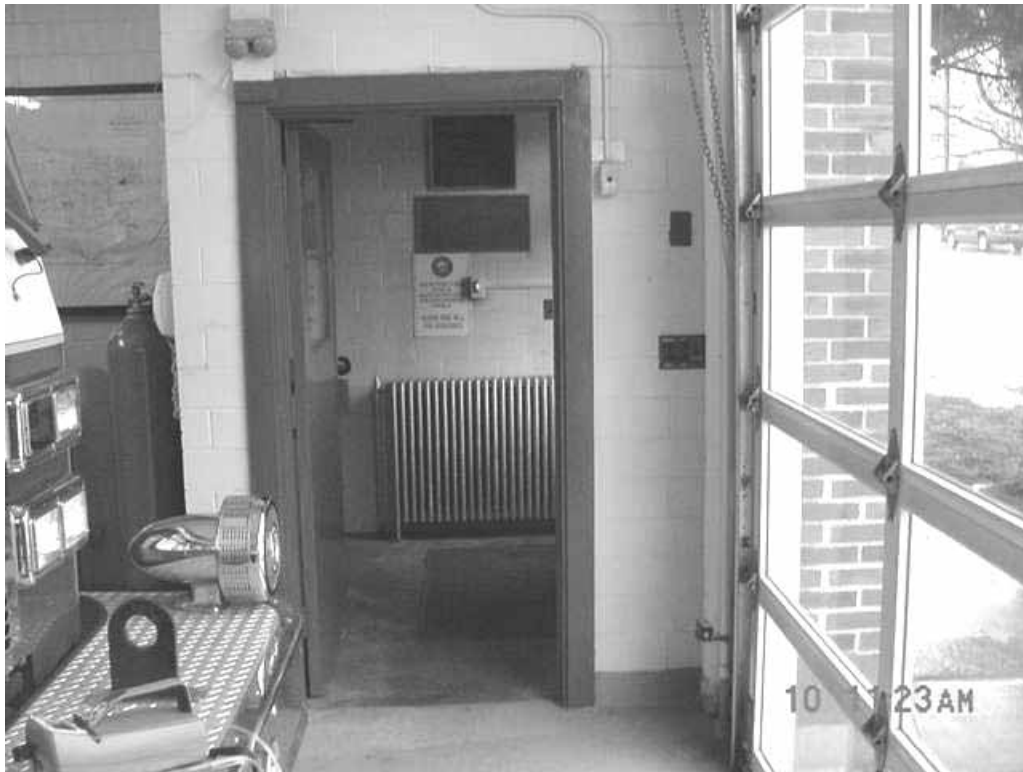
Picture 11

A number of pathways for vehicle exhaust and other pollutants to move from the engine bays into occupied areas on both the first and second floors were identified (Figure 1). The main pathways for vehicle exhaust emissions are the stairwell off the engine bay and around fire poles on the second floor. Although the stairwell is equipped with a door, it was observed propped open during the assessment (Picture 11). In addition, the door at the top of the stairwell had spaces beneath the door from which light

Stairwell Door to Engine Bay Propped Open

3. Ensure stairwell door leading off the engine bay, as well as the door at the top of the stairwell are closed. Seal doors on all sides with foam tape, and/or weather-stripping. Consider installing weather-stripping/door sweeps on both sides of doors to provide a dual barrier. Ensure tightness of doors by monitoring for light penetration and drafts.

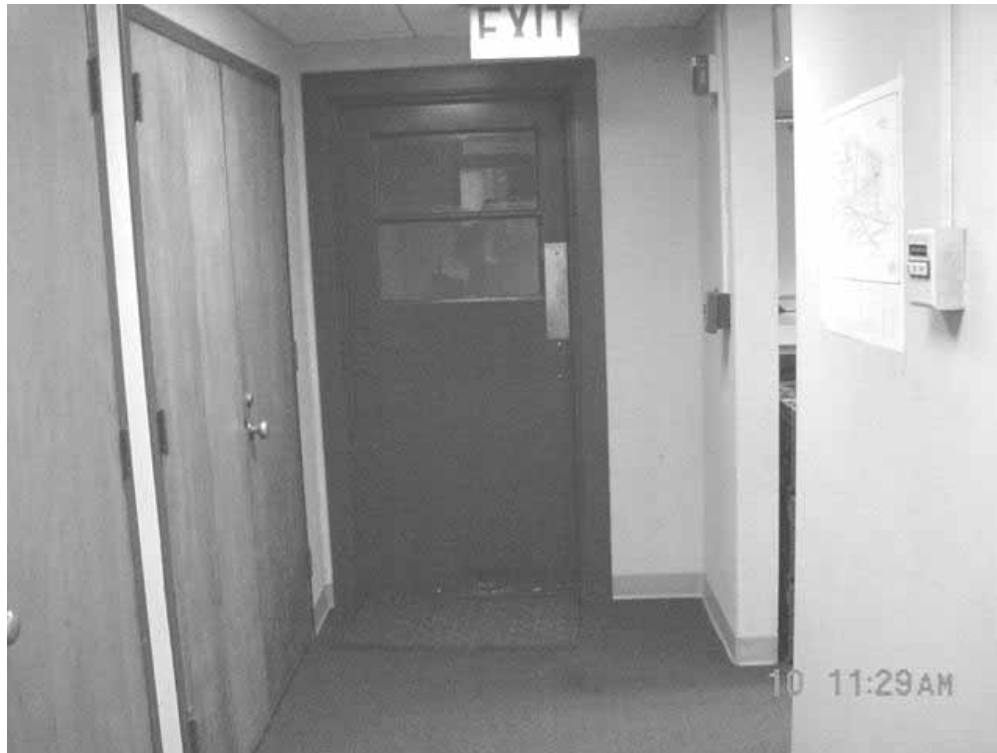
Picture 12

could be seen penetrating (Pictures 12 and 13). These spaces can allow vehicle exhaust emissions and particulates to migrate into the stairwell and subsequently into living quarters and office space on the second floor.

Door at top of Engine Bay Stairwell, Picture Taken From Inside Hallway

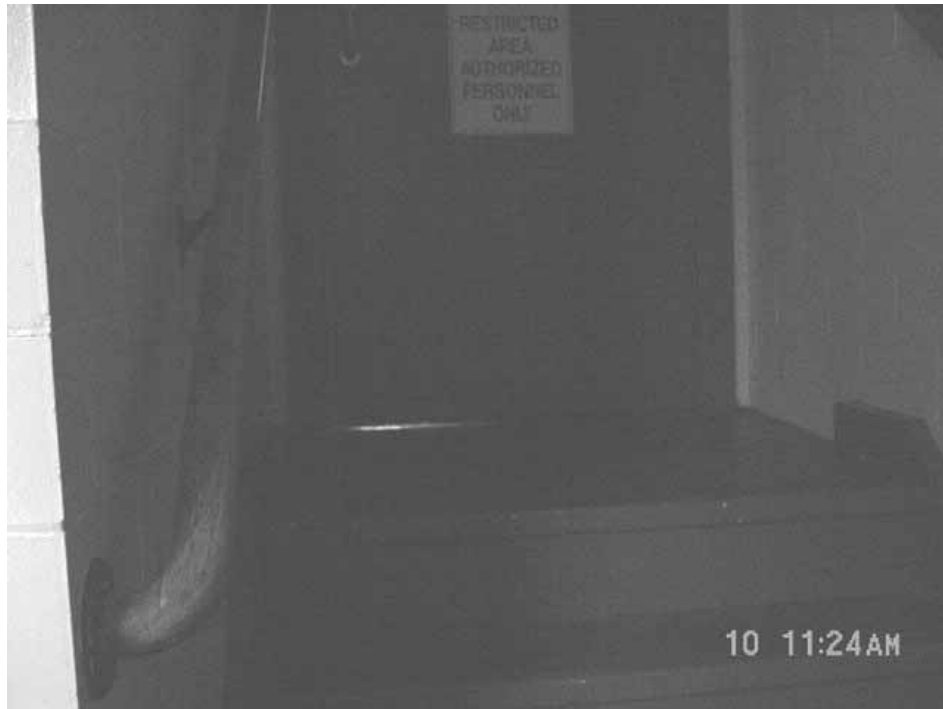
Picture 13

**Light Penetrating Beneath Engine Bay Stairwell Door Shown in Picture 12,
Picture Taken from inside Stairwell**

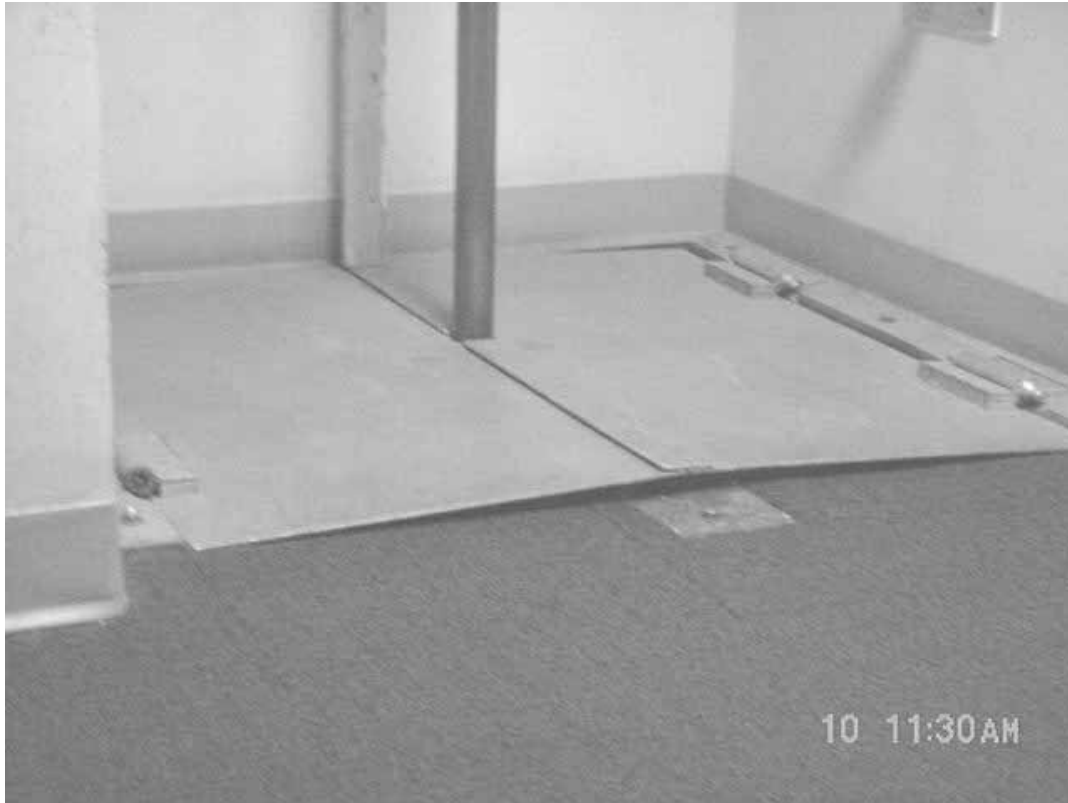
Picture 14

Other potential pathways include spaces around fire poles and utility holes. Fire poles are not enclosed with a standard “clamshell”-type of opening, but instead are outfitted with fabricated metal doors or hatches that do not close completely. Spaces in and around these doors create a means for airborne pollutants to migrate into occupied areas (Pictures 14 and 15). The ceiling/walls of the engine bays are penetrated by holes for utilities. These holes can present potential pathways into occupied areas if they are not airtight. Each of these conditions presents a pathway for air to move from the engine bays to occupied areas of the station. In order to understand how engine bay pollutants may be impacting the second floor and adjacent areas, the following concepts concerning heated air and creation of air movement must be considered:

Metal Doors over Fire Pole Opening

4. Consider installing an automatic control to activate the engine bay exhaust system as engine bay doors open.
5. Ensure all utility holes are properly sealed in both the engine bay and their terminus to eliminate pollutant paths of migration.

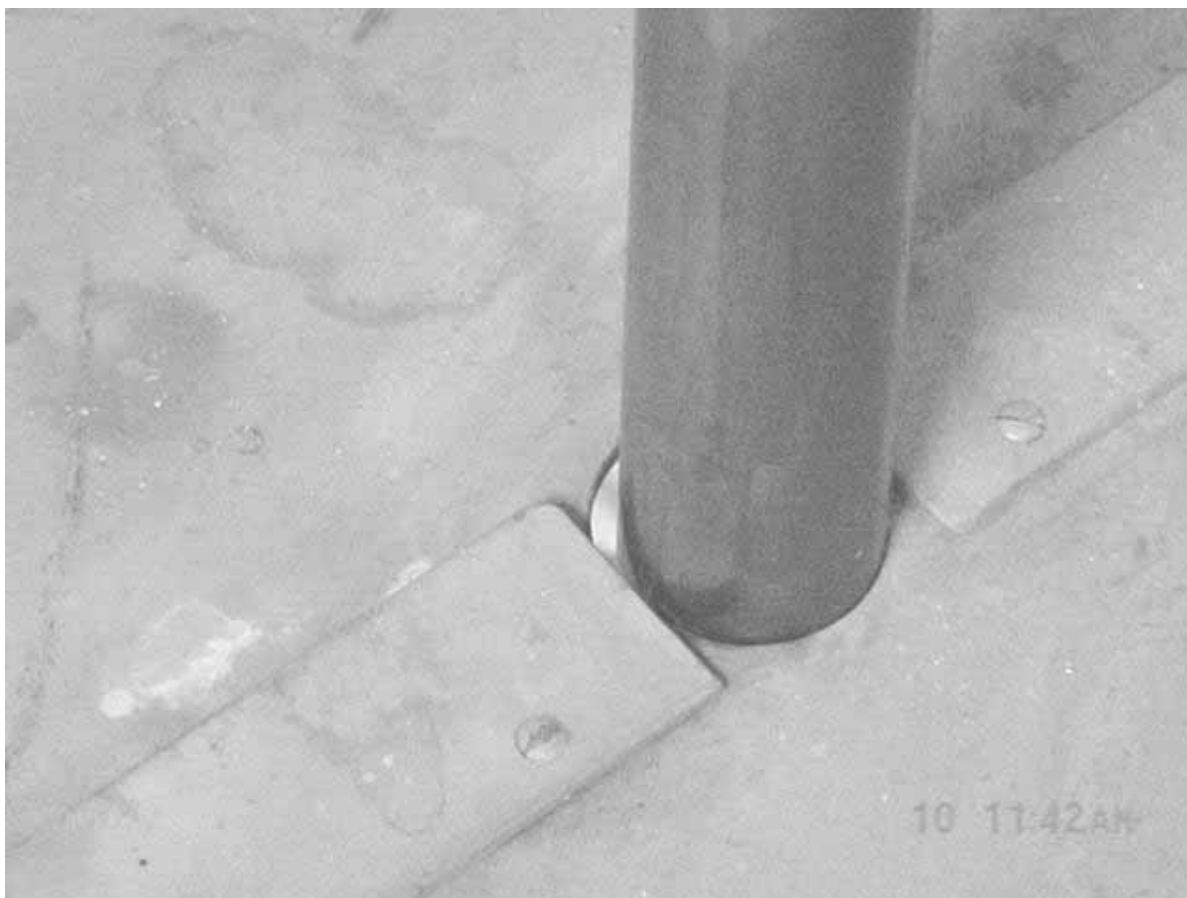
Picture 15

Spaces around Fire Pole
